**TECHNICAL INVESTIGATION INTO THE ACCIDENT OF
THE B737-800 REGISTRATION 5Y-KYA OPERATED BY
KENYA AIRWAYS THAT OCCURRED ON THE 5th OF
MAY 2007 IN DOUALA**

Operator	Kenya Airways Limited
Aircraft	Boeing 737-800; registration 5Y-KYA
Date and time of accident	Saturday 05 th May 2007 at 0008 (local time)
Location of accident	3.95570 N 9.75090 E (03 57 1883 N 009 44 58 E)

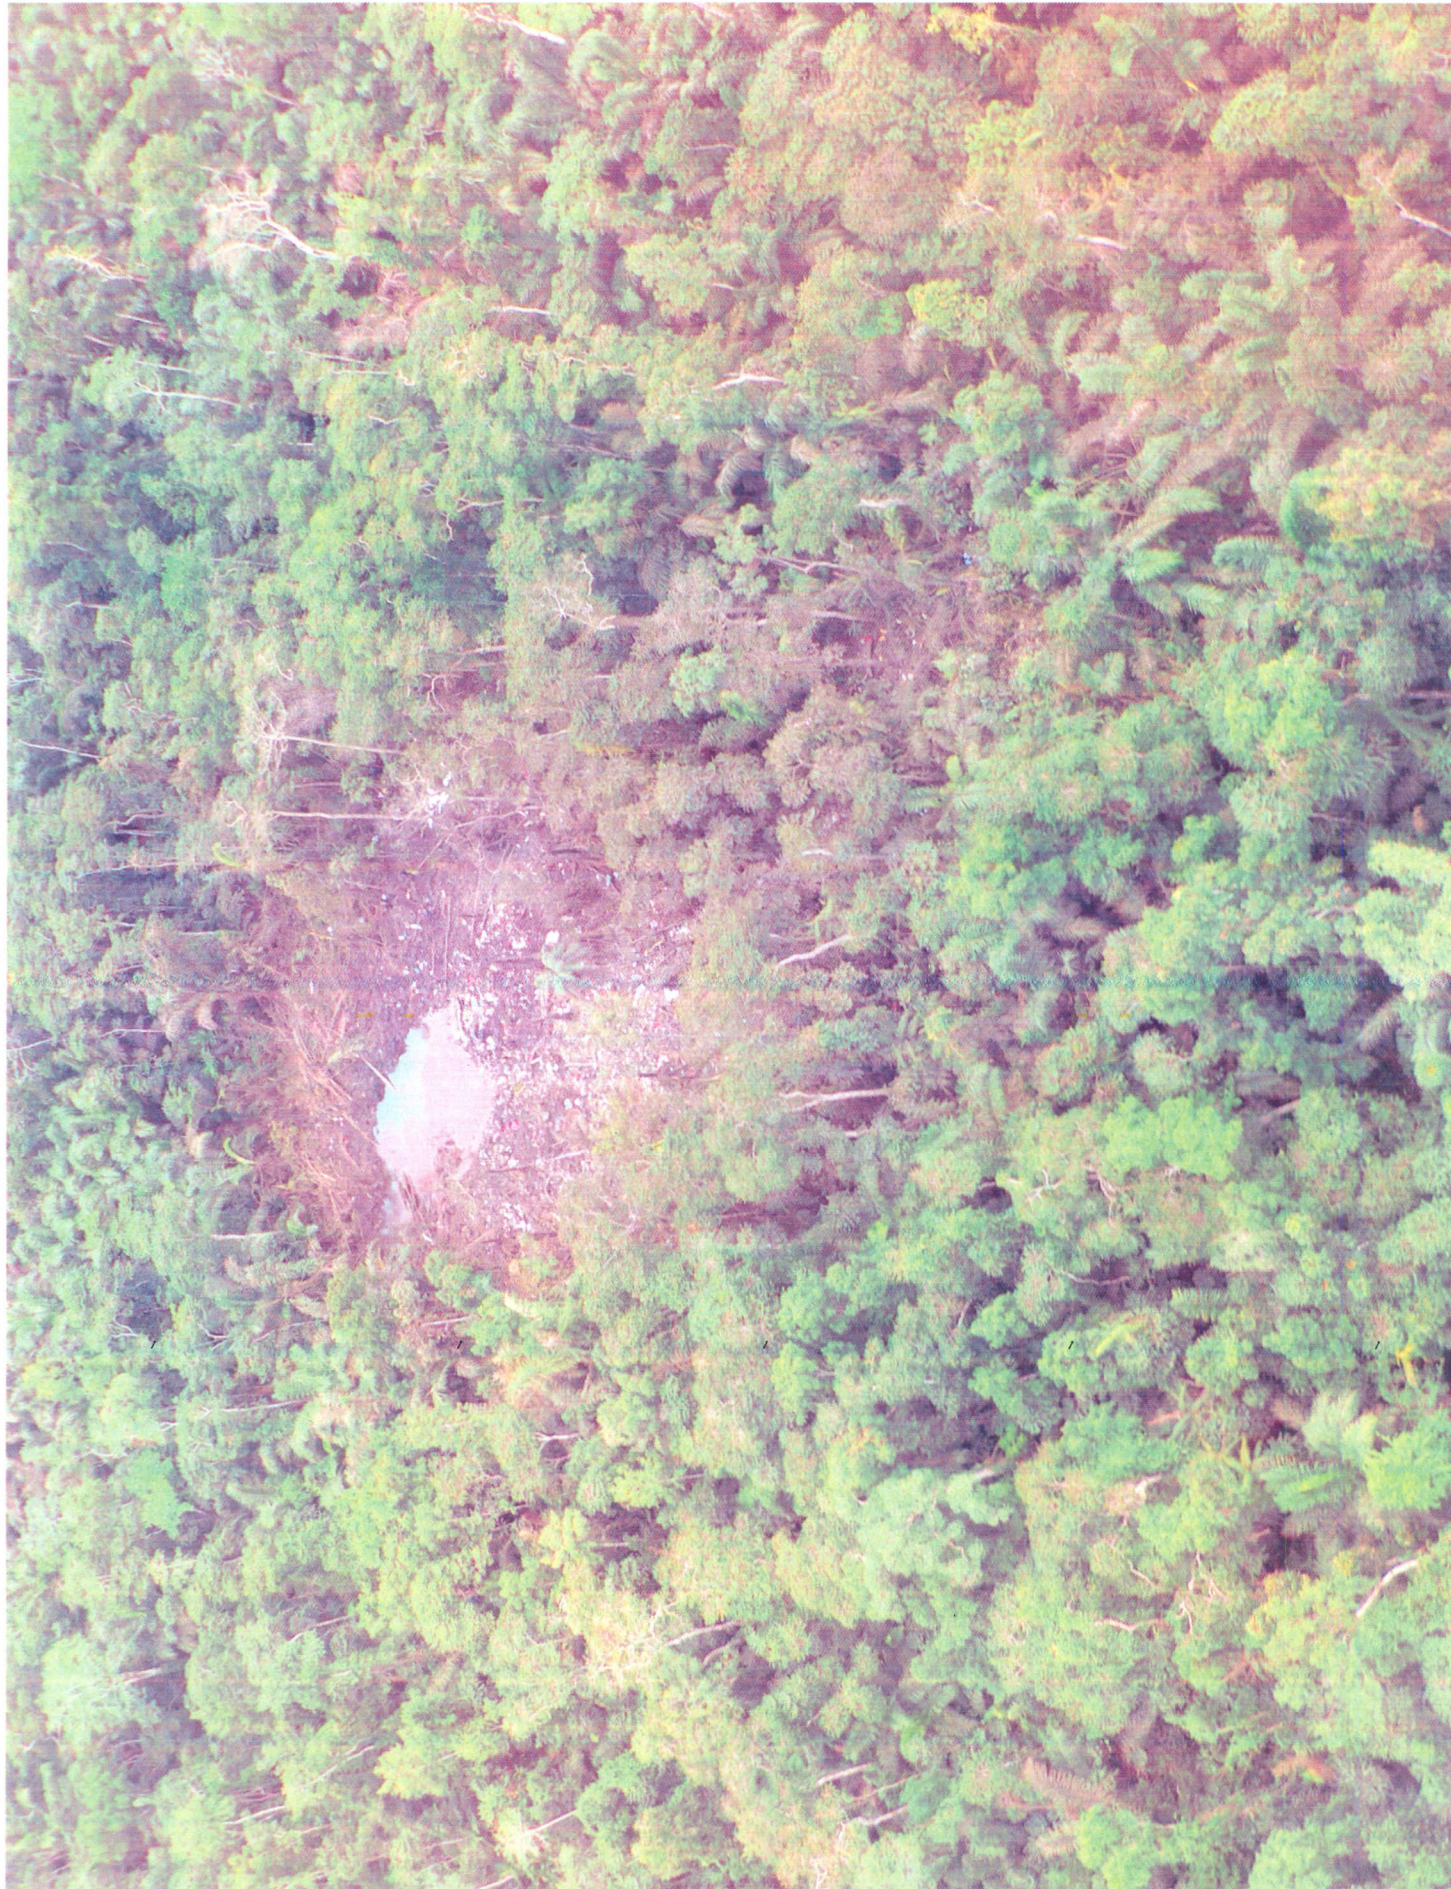
Aerial photo of crash site

A significant mass of overturned mud is found on the North West and South West borders of the crater. The vegetation all around is covered with mud up to 30 m away. The trees in the immediate vicinity of the crater are lying down because they were either uprooted or broken. The damage done to the vegetation extends over a surface area of about 2000 m². The North West side of the crater is the most affected.

The content of the airplane (flight deck, cabin and cargo compartment) is found concentrated in the 70° direction as follows: nearest to the crater-economic class (blue seats); next first class (red seats); and finally the front part of the plane.

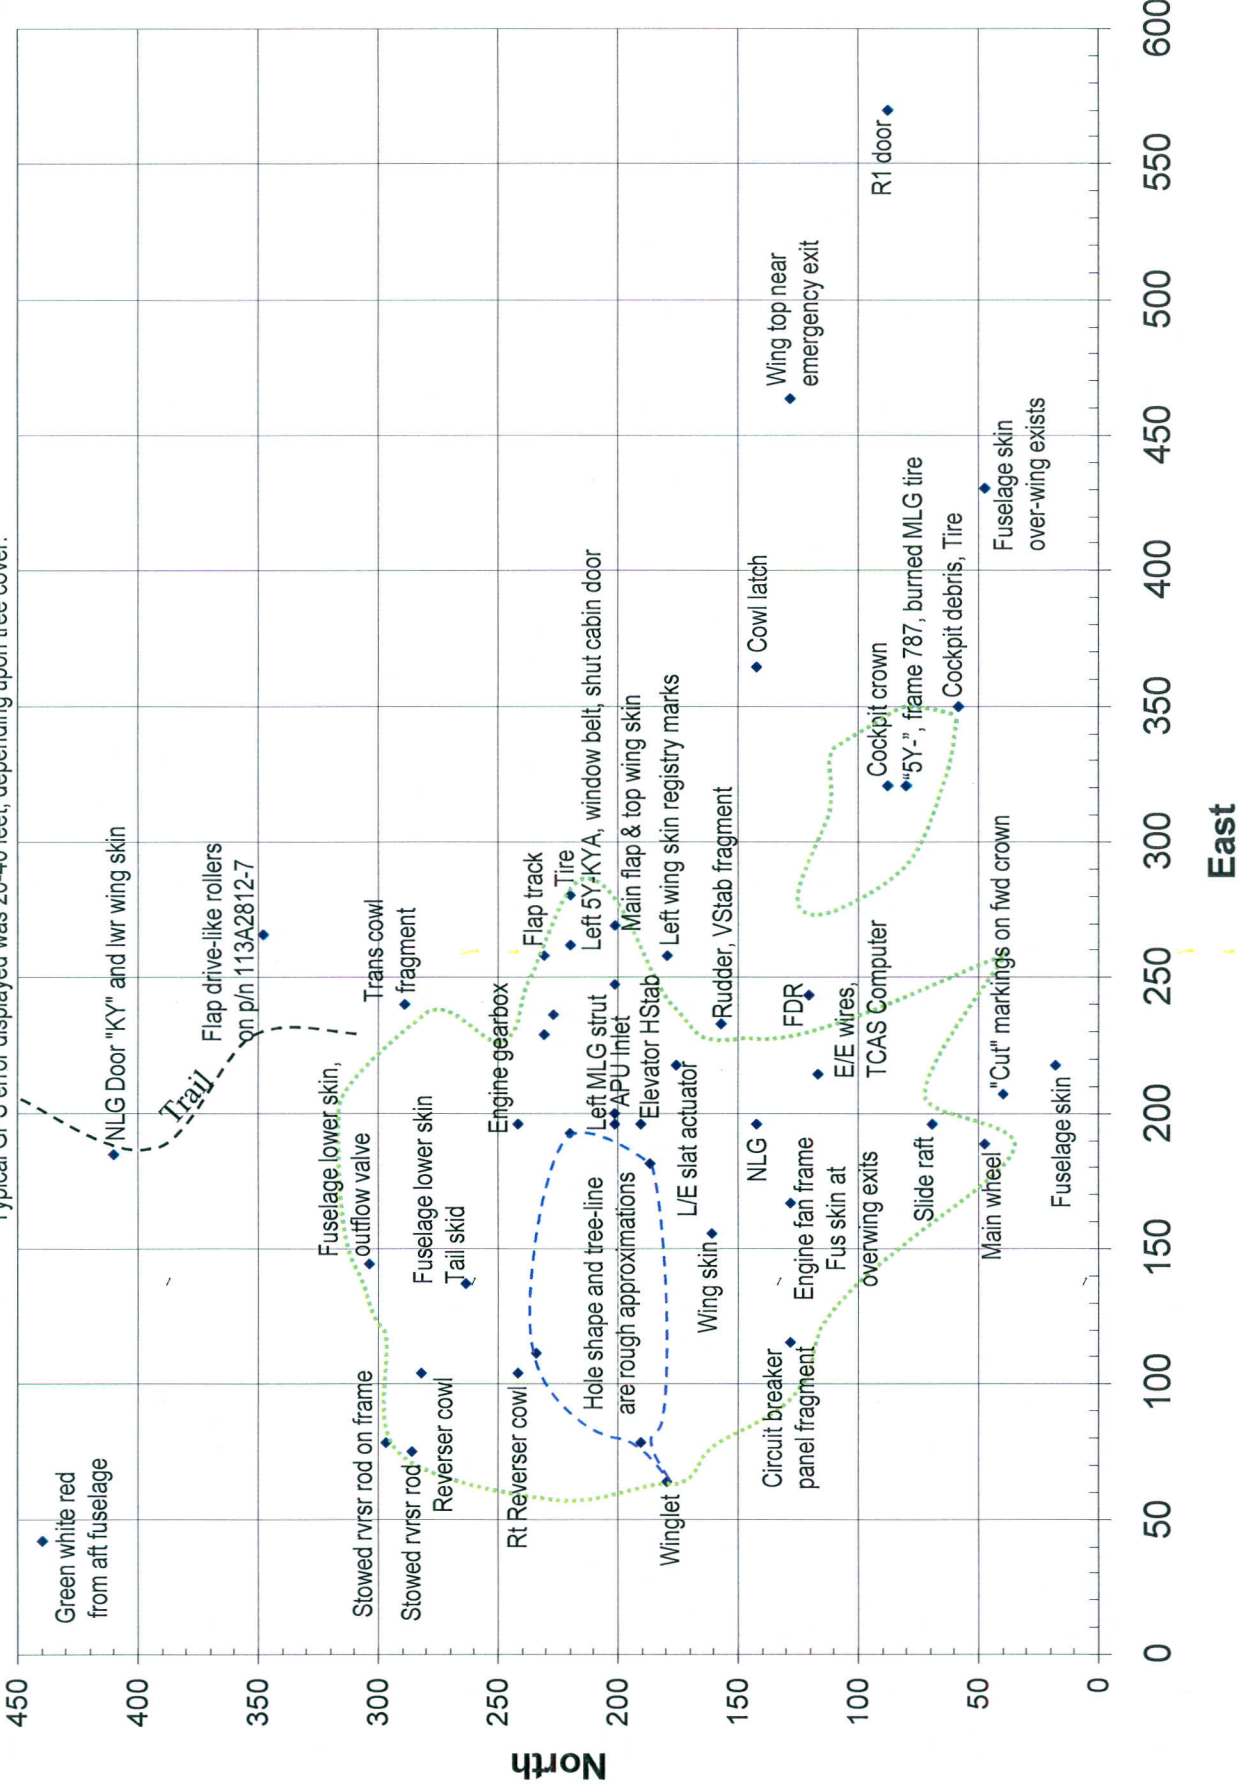
KA507 Debris Coordinates

The detailed plan of the distribution of the significant elements found, as well as aerial photographs of the site and its description are attached to this report as Appendixes 2 and 3.
